# APPLIED APPROACH SLAB SETTLEMENT RESEARCH, DESIGN/CONSTRUCTION

FINAL REPORT ~ FHWA-OK-13-09  
ODOT SP&R ITEM NUMBER 2227

Gerald A. Miller, Kianoosh Hatami, Amy B. Cerato, Colin Osborne  
School of Civil Engineering and Environmental Science  
University of Oklahoma

August 2013

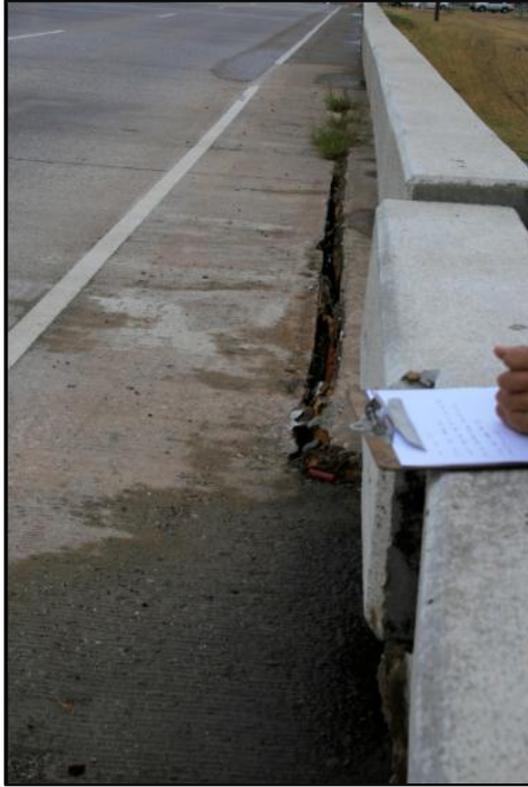
Examples of common problems are seen in Figure 4.4. A large gap can be seen between the wing wall, moving outwards, and the approach slab on Tecumseh Road over I-35. The developing bump on S.H. 6 over West Elk Creek has pulled the seal between pavement slabs apart. A concrete surface channel designed to carry water away from the embankment on S.H. 11 over I-35 failed and collapsed into a 3’ deep void beneath the channel.

**(a) Horizontal separation between wing wall and approach slab**

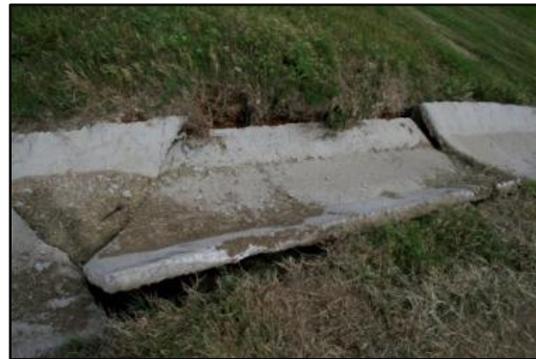
**(c) Surface drain channel caving into 3' deep void**

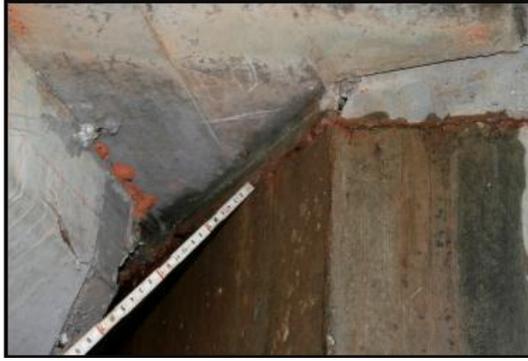
Some examples of erosion taking place through the abutment are shown in Figure 4.5. Soil stains could be observed on the abutment wall originating in these cracks suggesting that some soil loss is taking place through these cracks.

**(a) Water and soil flowing through a cracked abutment on S.H. 59 B over Coon Creek, photographed May 21<sup>st</sup>, 2011**

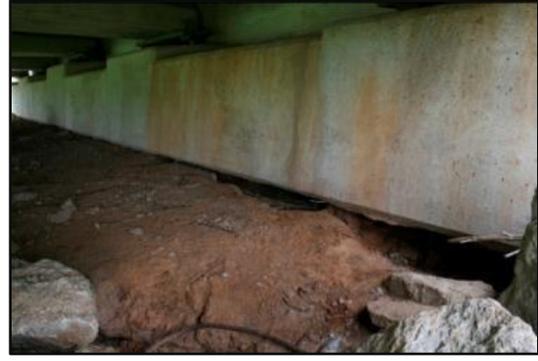
**(b) Red stains on the abutment indicate the possibility of soil loss through U.S. 177 over the Salt Fork, photographed June 2<sup>nd</sup>, 2011**

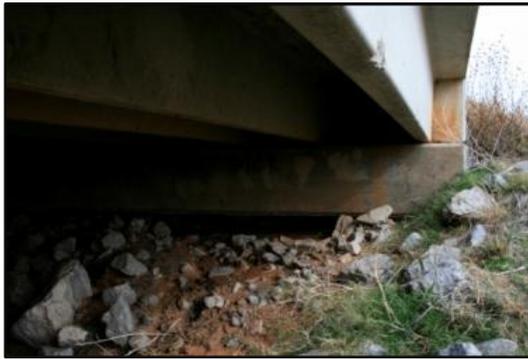
**(c) Red staining on abutment at S.H. 152 over Lake Creek Overflow, photographed November 11<sup>th</sup>, 2011**

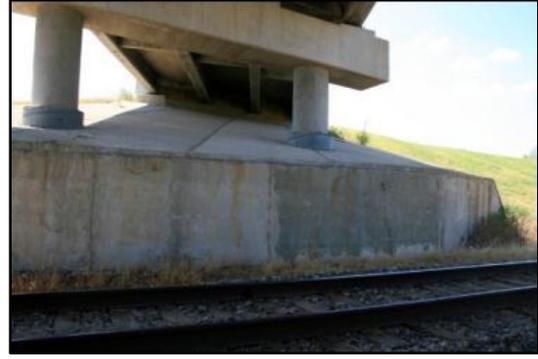
**(d) Red stains originating from crack at S.H. 1 over BNSF, photographed August 26<sup>th</sup>, 2011**

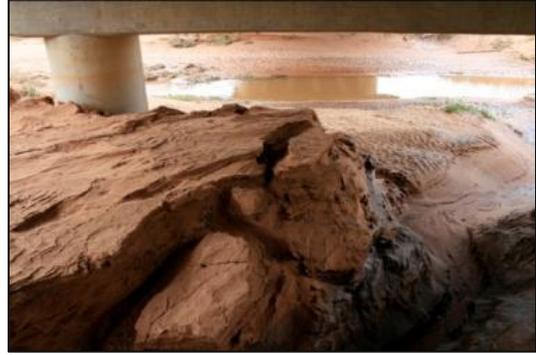
**Figure 4.12 Erosion channel at S.H. 152 over Lake Creek continues**

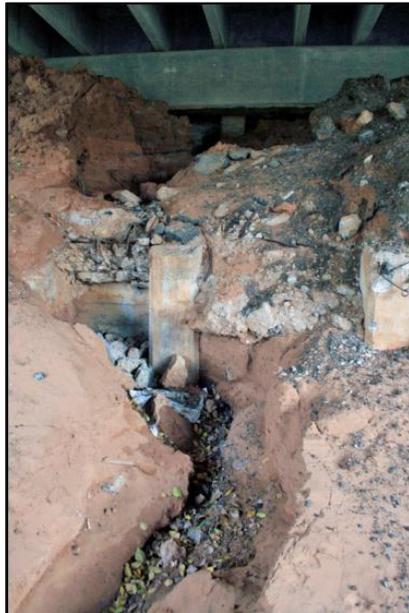
A similar channel was observed at S.H. 152 over Willow Creek and is shown in Figure 4.13. Expanding foam maintenance was used beneath S.H. 9 over Running Creek, but the erosion continued and a void is present even below the foam as seen in Figure 4.14. An example of erosion beneath the abutment is presented in Figure 4.15.

**Figure 4.13 Erosion channel from beneath abutment at S.H. 152 over Willow Creek**

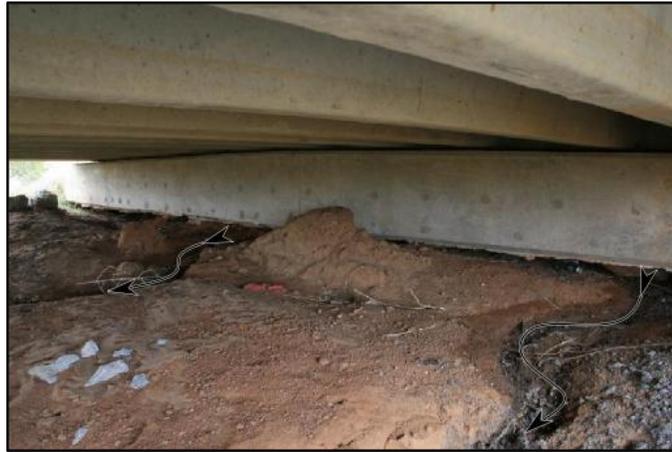
**Figure 4.15 Erosion flow beneath abutment at S.H. 152 over Lake Creek Overflow**

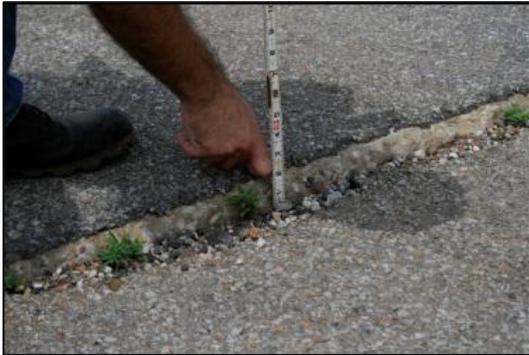
**Figure 4.27 Bump at U.S. 177 over Salt Fork, Approach B-2**

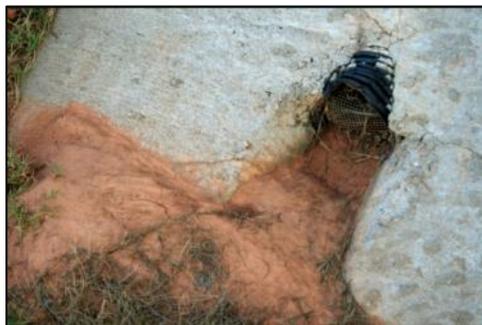
Another observed issue was soil being transported through drainage pipes. This indicates that improper filtering is allowing soil into the perforated pipes which are present in backfills and in slope walls. Shields Boulevard over I-35 provides an example of this. The pipes at this site are not only carrying water, but soil. Soil was observed to have flowed out of the outlets at this location, and voids were present at the abutment. This location has 8"-12" of settlement at the wing-walls, distress of the structure and approach slab, and a significant bump. The drainage outlet at the bottom of the slope wall is shown in Figure 4.32 and a developing void beneath the slope wall at the foot of the abutment is shown in Figure 4.33.

**Figure 4.32 Soil flowing from underdrain outlet**

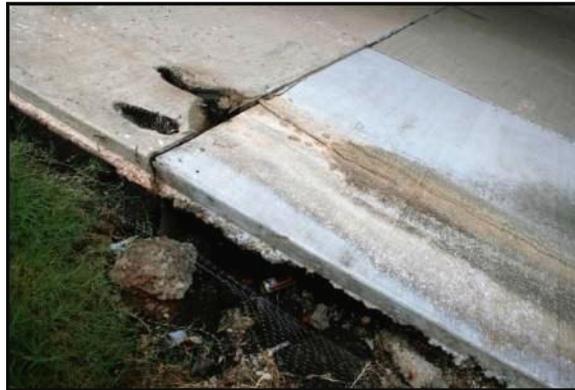
the slope wall. It is unclear which outlet serves the backfill and which serves the slope wall. Outlets are only on this side. The seal between the slabs had failed and therefore the water was poured directly back onto the embankment leading to erosion. The outlet and resulting 16" void is shown in Figure 4.34.

**Figure 4.34 Water flowing from outlets into embankment, Tecumseh Rd. over I-35. (note large void under slope wall)**

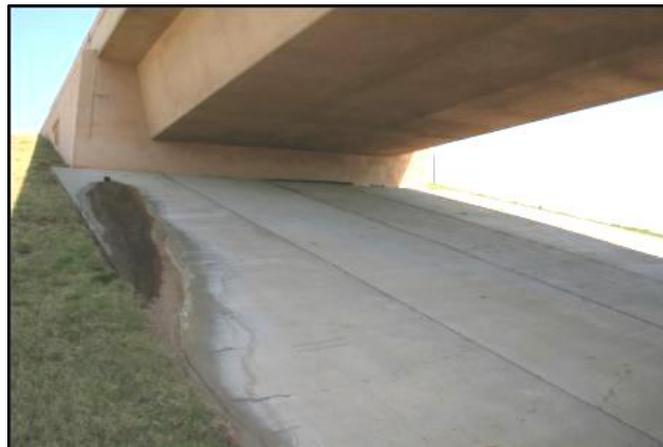
A similar situation was observed at Shields Boulevard over I-35. Though there were no cracks in the slope wall, the water flowed off the side of the slope wall. This led to water reentering the embankment and erosion. Figure 4.35 shows water flowing back into the embankment.

**Figure 4.35 Outlet drain at Shields Boulevard over I-35, Embankment N-2**

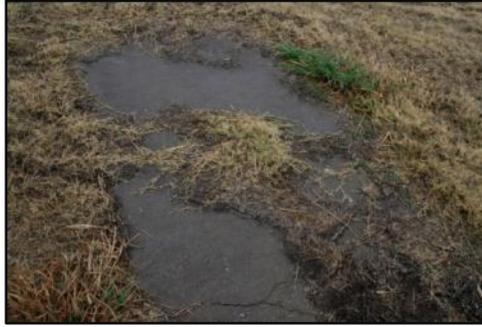
In many locations, the outlet drain is buried or crushed. The underdrain is useless if water cannot flow out of the outlet. Water becoming trapped in the embankment could have detrimental effects on the embankment performance. In Moore, bridges carrying 19<sup>th</sup> St. over I-35 and I-35 over Main Street have drains which are buried and blocked. No significant erosion was observed at either bridge, but the embankments were observed to have settled, as shown in Figure 4.36.

**(a) Grass and soil blocks drainage outlets at 19<sup>th</sup> St. over I-35**
